**Phare CBC Projekt  
Engineering Works for Closing of  
the Uranium Mines at Eleshnitsa and  
Dospat  
Diaphragm wall intake structure**

**C&E · Consulting und  
Engineering GmbH**

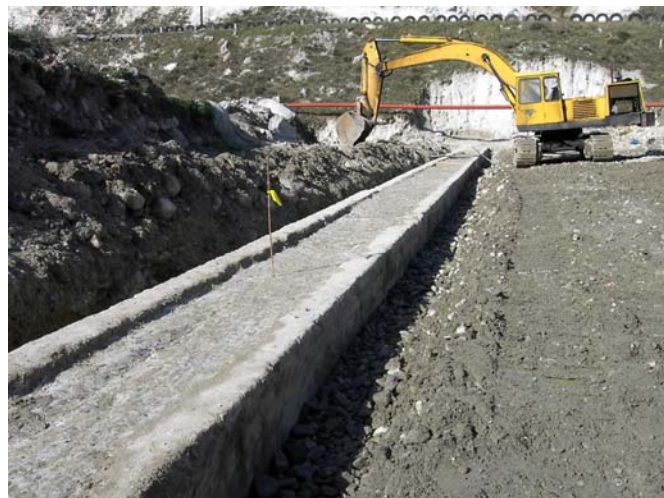
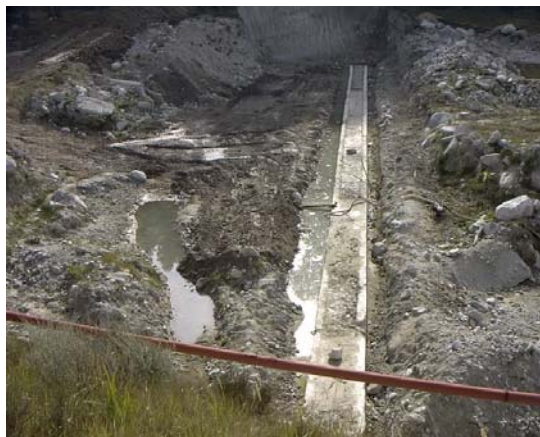
1990 the uranium treatment was discontinued in Eleshnitsa. The tailing pond was not kept safe after this and therefore the leachate occurred reached in the existing receiving water „Wolves Gully“ in the Mesta. The leachate amount was considerably increased due to the infiltration of the spring water. The objective was not only to remediate the tailing pond (surface sealing of tailing pond), but also to prevent the spring water supply. As a solution we choose the applying of bentonite diaphragm, which will fulfil the task together with the thick dam.

- Bentonite diaphragm wall, d = 60 cm, l = 60 m, height depth = 10 m with combination of coming rock horizon
- Construction of thick dams (clay sealing) d = 2,0 m; h = 2,5 m; l = 60 m
